# ANNUAL REPORT FOR 2016

**Mile Branch  
Guilford County  
TIP No. R-0609IA  
COE Action ID: 2004-00340  
DWR #: 2006-0331**

Prepared By:  
Natural Environment Section & Roadside Environmental Unit  
North Carolina Department of Transportation  
July 2016

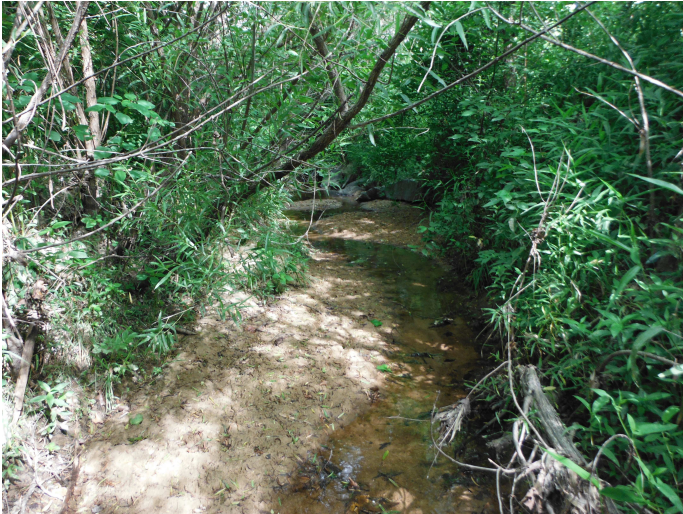
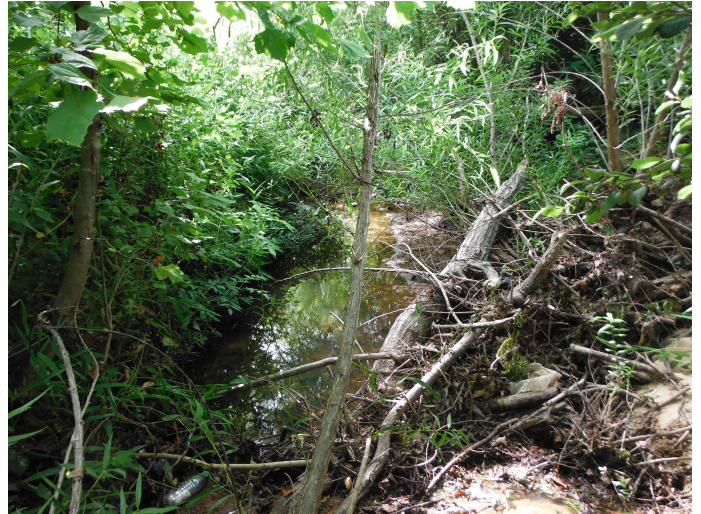
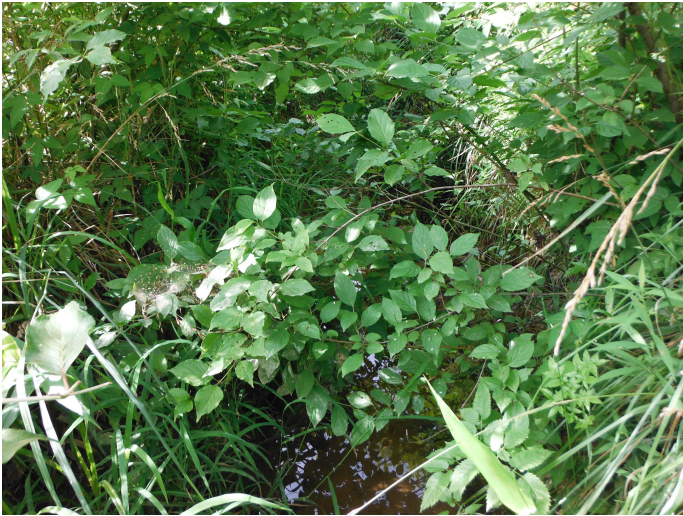
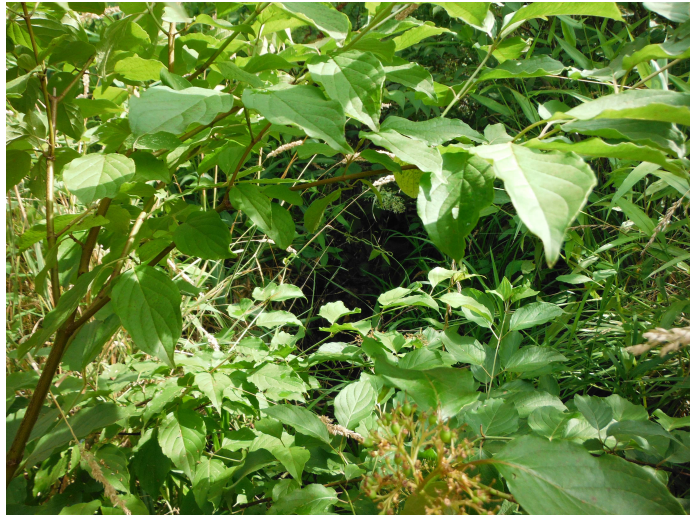
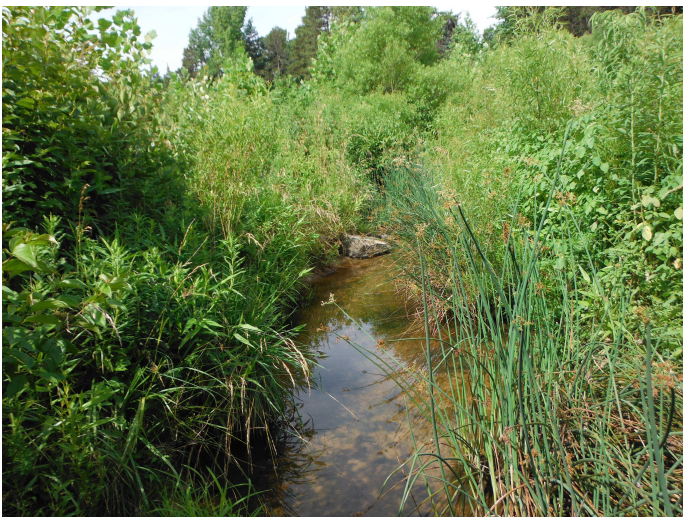
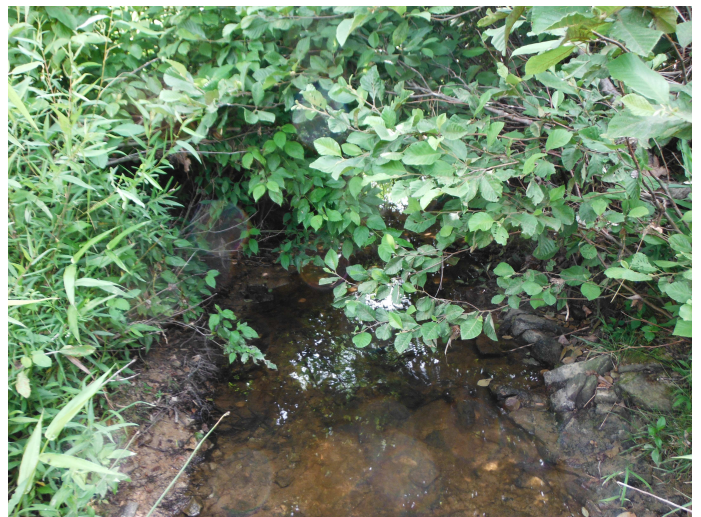
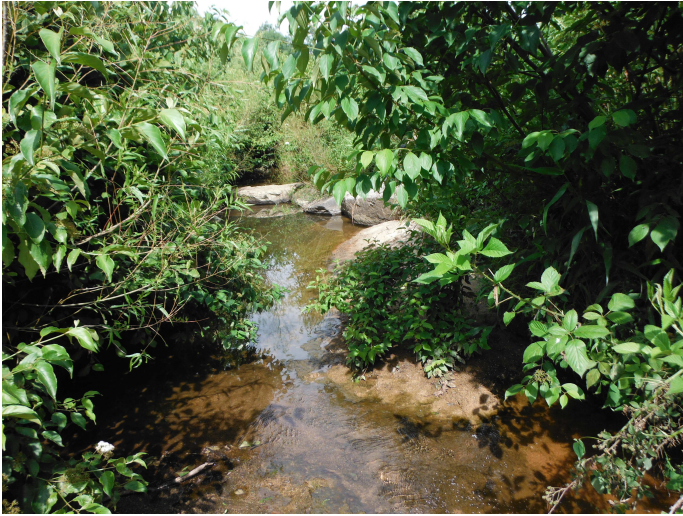
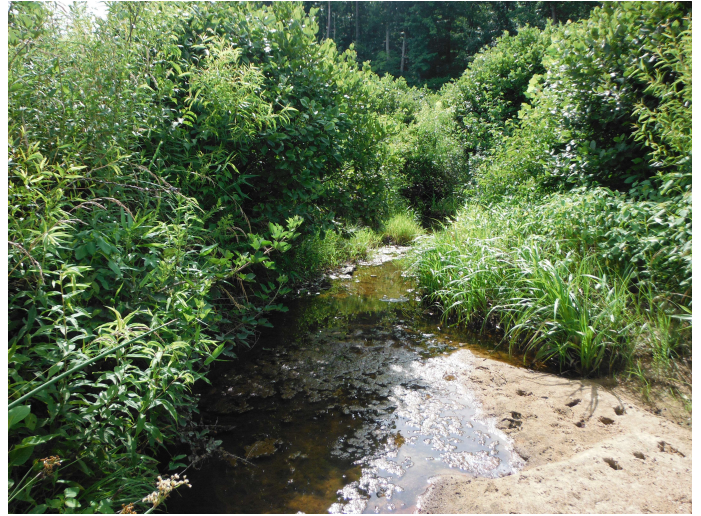
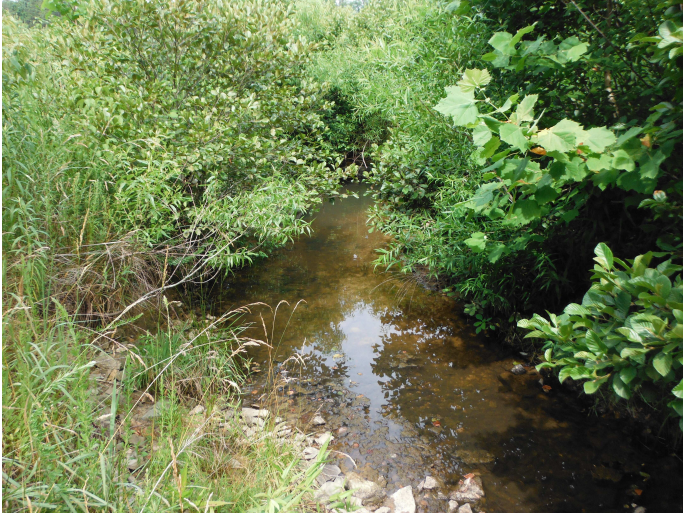
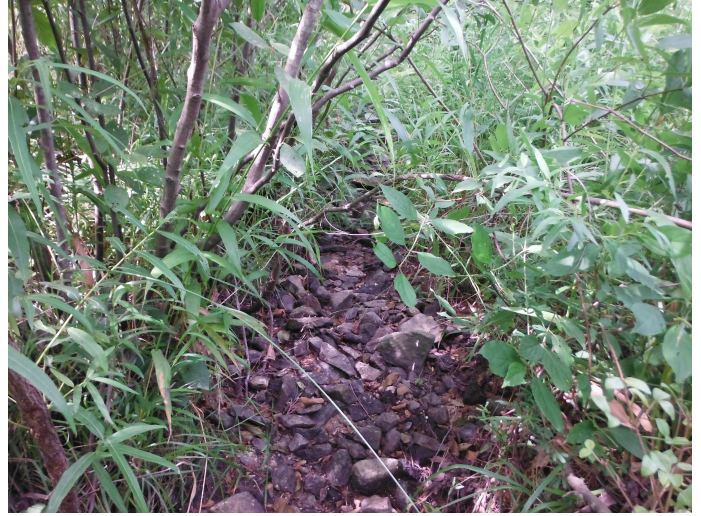
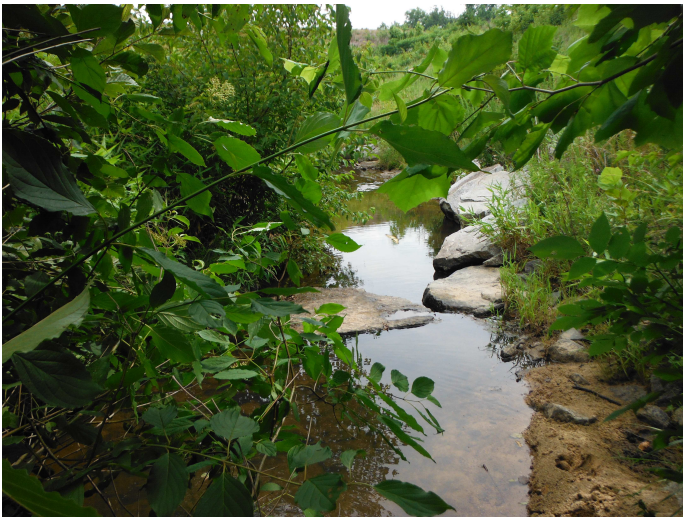
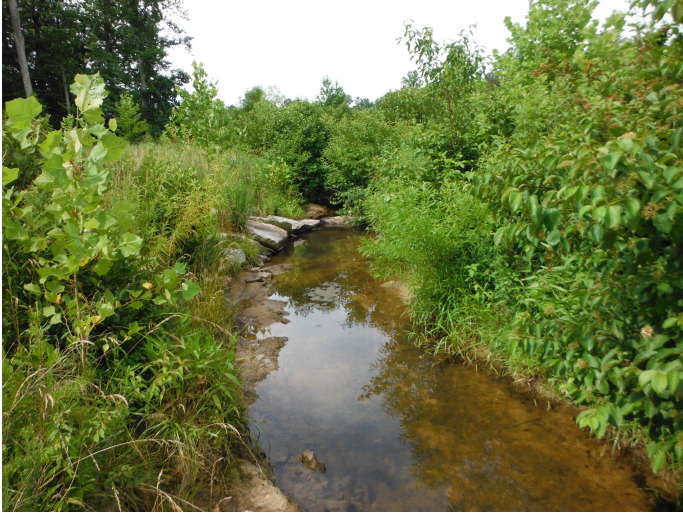
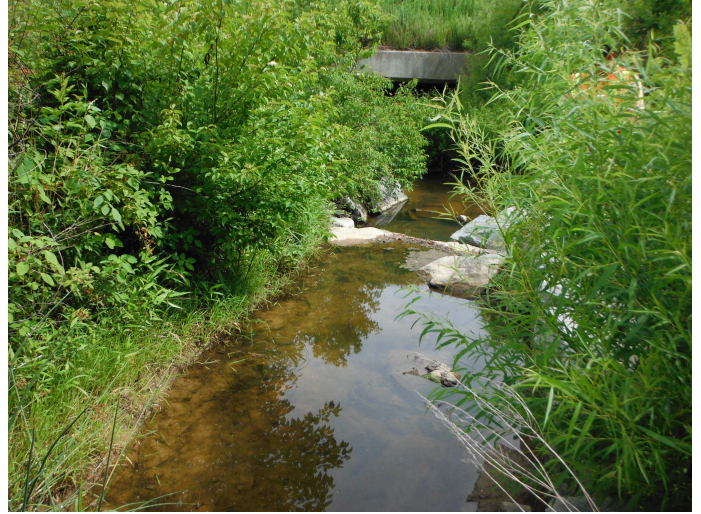
A visual inspection of the channel and photos taken from photo points 1 through 6 showed that the channel bed is stable throughout the stream relocation at this time.
